The Railway from Pill Junction to Portishead in March 2015

A series of pictures
taken to record the status of the old line
following the major clearance operation

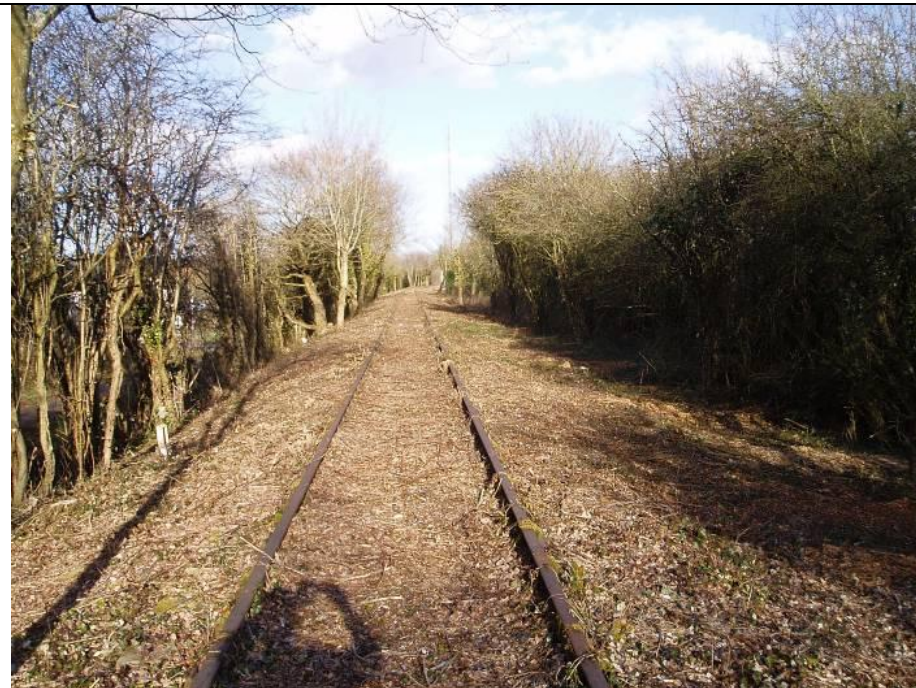
Photo 3260088

A look back along the line towards Pill and the right-hand curve towards Pill Junction, about 250 yards away.

A wooden gate (not locked!) has been inserted in the boundary fence, just out of view to the left, by the side of the pedestrian/cycle path. The gate provides access across the track to what looks like a mobile phone mast.

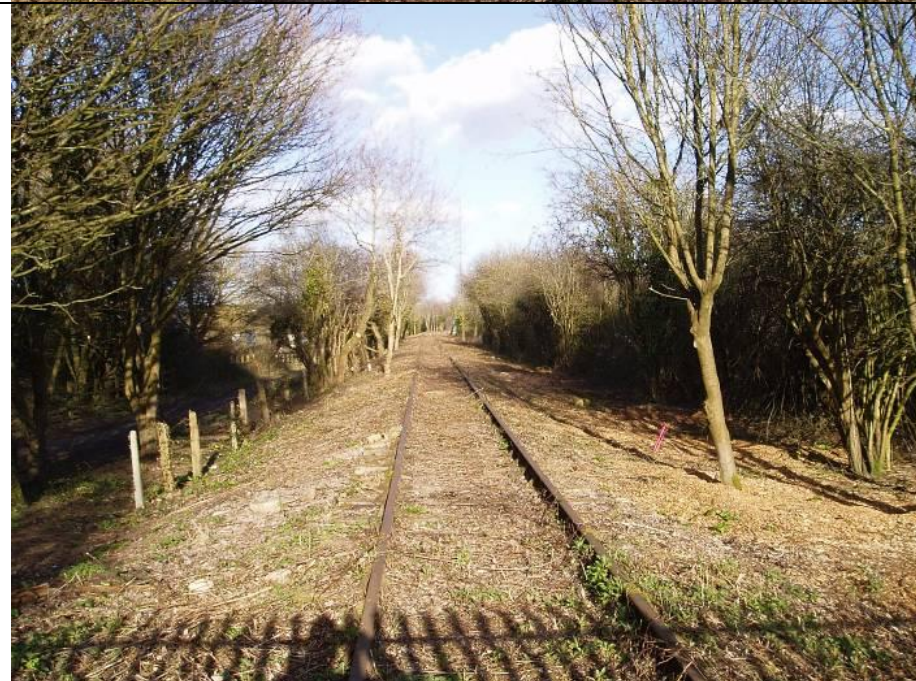
Photo 3260089

The view looking back towards the curve into Pill Junction.

Taken about 450 yds towards Portishead from Pill Junction, just before the M5 bridge.

The shadow shows there is a metal fence across the line but the fence on the left is not in a condition to prevent access to the line!

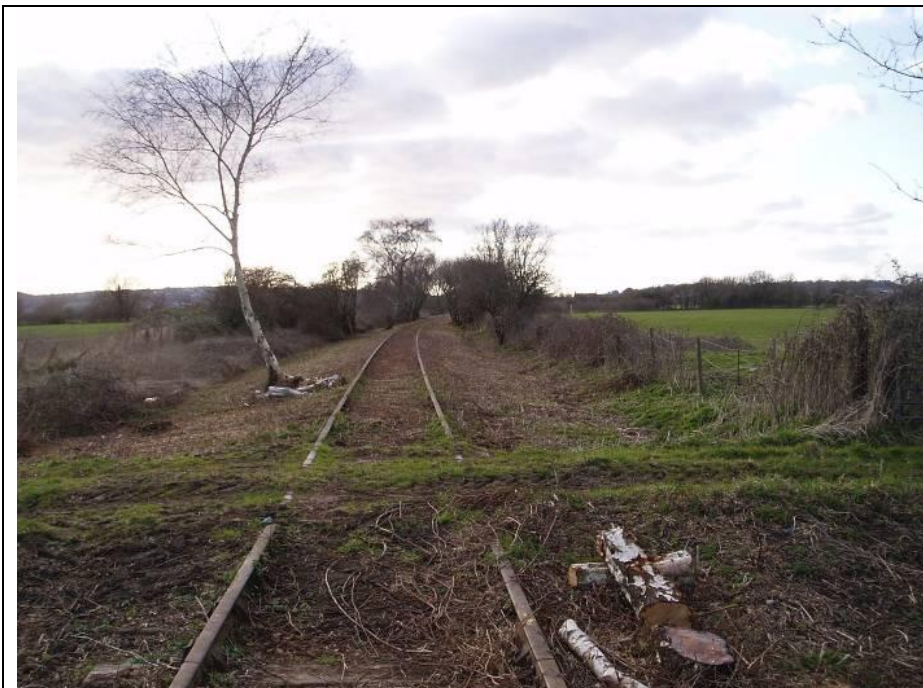
Photo 3260107

A farm crossing to fields on the left, from Elm Tree Farm in Sheepway, to the right.

One of at least 7 farm crossings along the 2¾ mile stretch from Pill Junction to Portishead.

Old maps show 7 such crossings but there is evidence of there having been 8 farm crossings between Pill junction and Portishead.

Following reinstatement of the line, no farm crossings will exist, as all line crossings are considered to be unacceptable sources of danger.

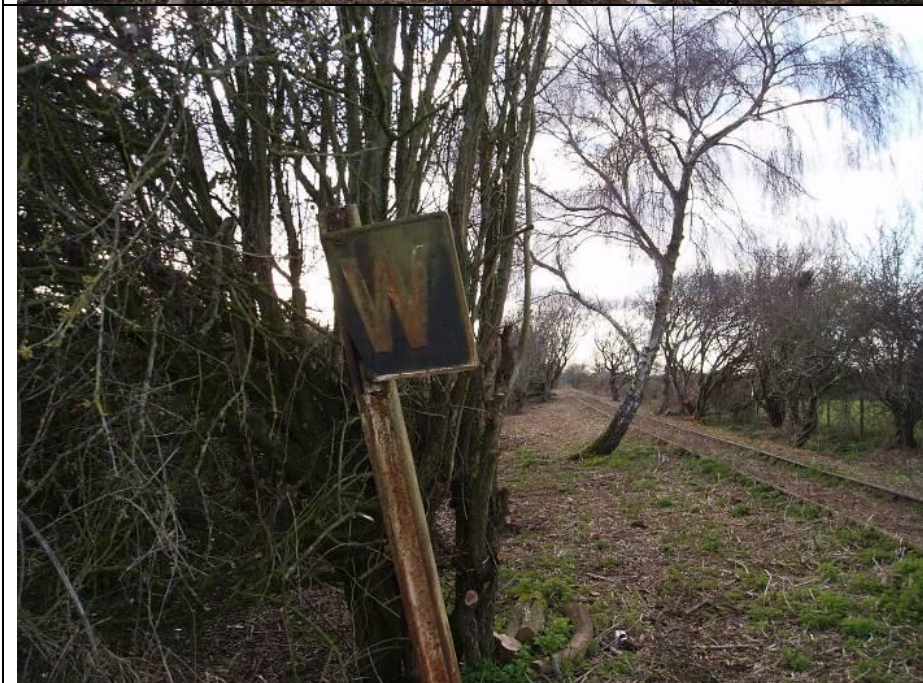
Photo 3260110

The remains of a sign that once upon a time would have said "SW". Back in the day, this would have meant "Slow. Whistle." A very necessary instruction to the driver due to the many farm crossings!

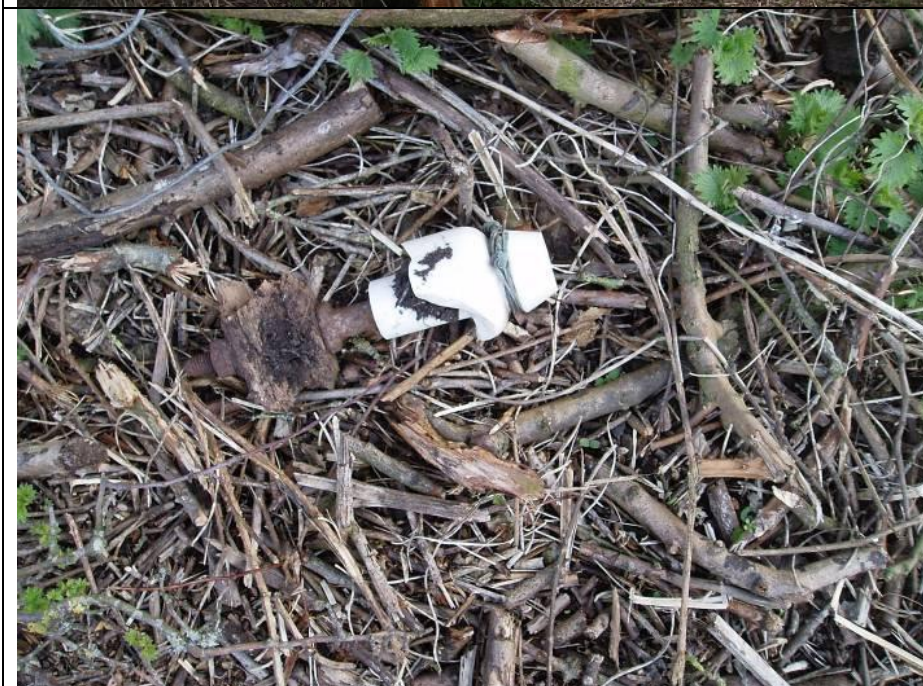
Photo 3260111

Railways usually had telegraph poles alongside the line, with telephone wires slung from pole to pole.

The wires were bare (uninsulated) tinned copper wire, wound around porcelain insulators mounted on wooden cross-bars towards the top of each pole.

Here's a porcelain insulator that has seen better days! But the wire is still in good condition.

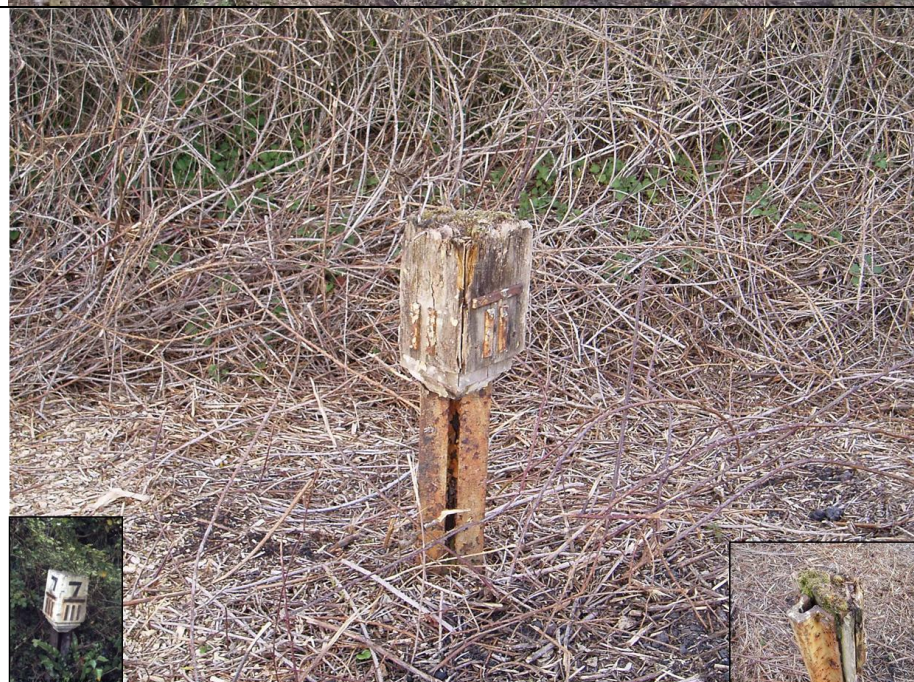
Photo 3260116

This was the marker-post showing 128½ miles from Paddington.

The numbers of miles (128) above the horizontal bars are missing, though the bar on the right is still in place. The "11" below the bar means "2 quarters".

The inset pictures show roughly what it once looked like and also that it is set on a post made from a piece of old broad gauge rail.

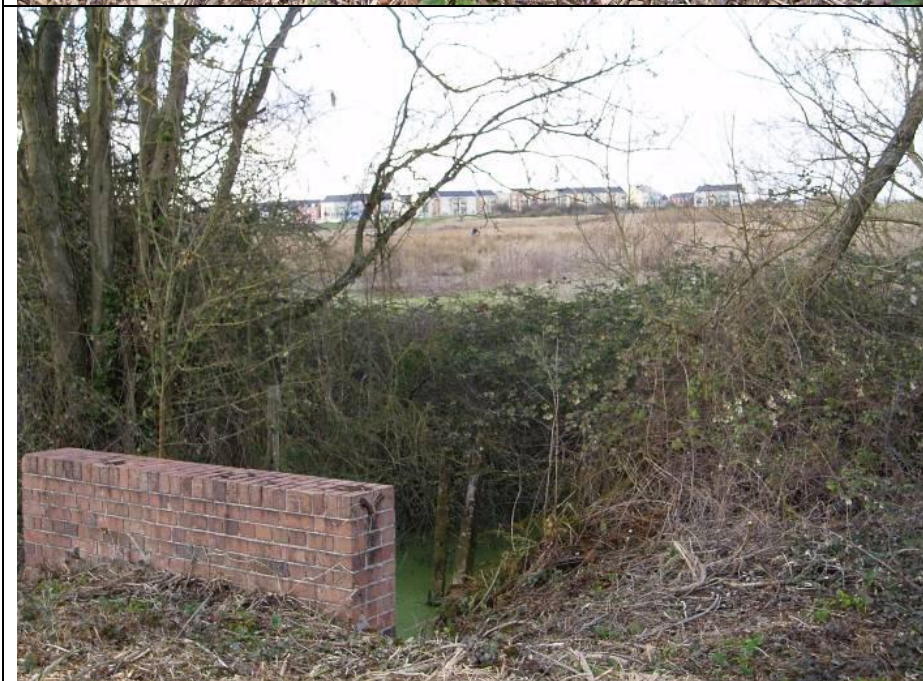
Photo 3260125

One of numerous culverts carry rhynes under the permanent way.

This one looks like it was re-built in the late 1940s maintenance works carried out along the line, following nationalisation.

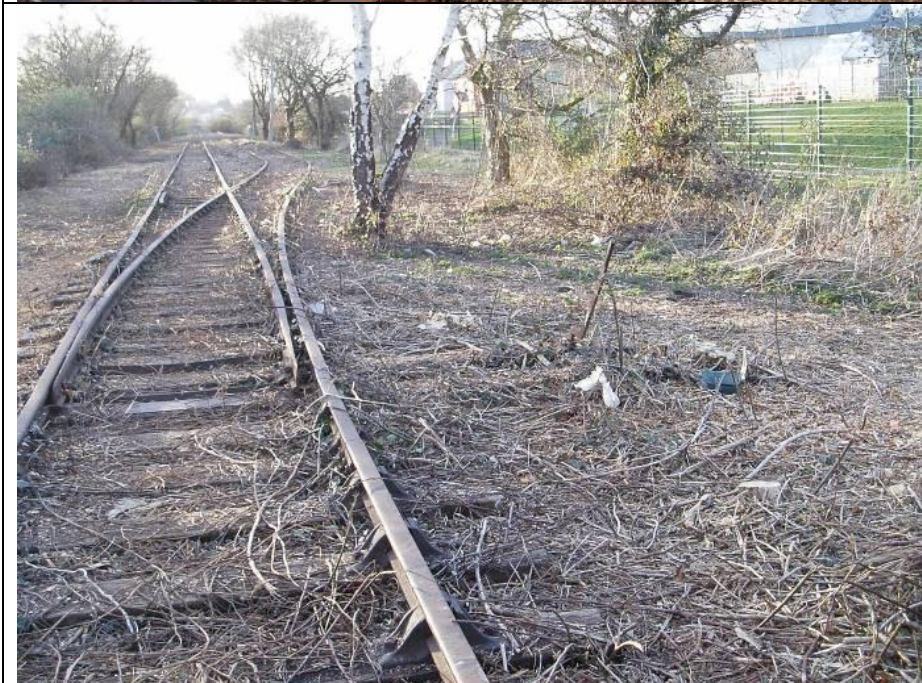
Photo 3260134

The single track becomes doubled to form a passing loop. The points operating lever is to the right of the line, beyond a piece of rubbish.

The passing-loop was laid to cope with the GWR150 celebration train that ran down the line but actually formed a loop that should have been installed following closure of the line to freight in 1981.

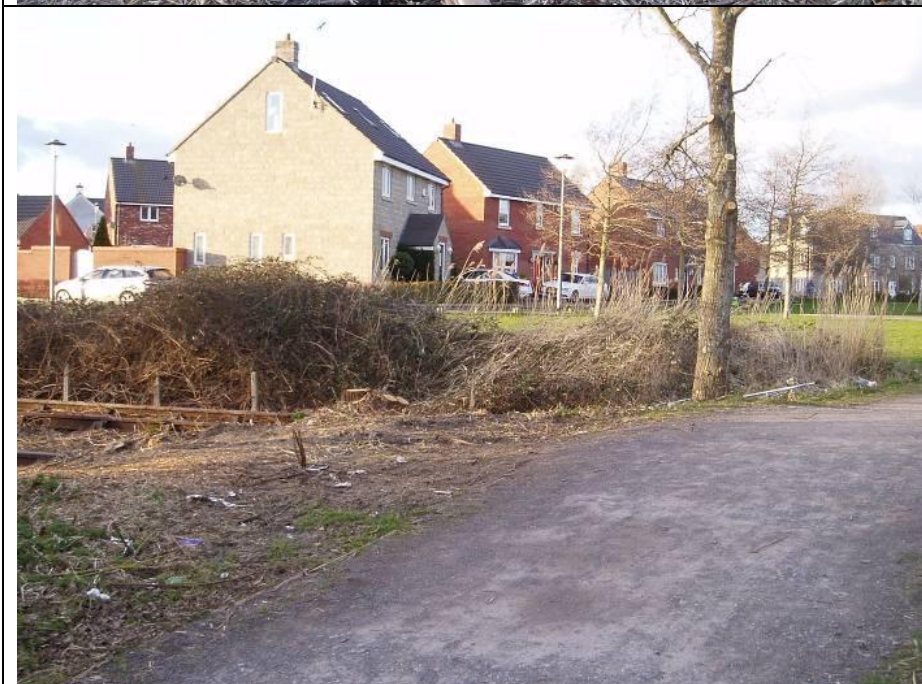
Photo 3260138

The well-used permissive crossing between The Vale and The Village Quarter, near Trinity School.

“Permissive” means “not permanent” and it is intended this crossing will be replaced by a full-access pedestrian bridge.

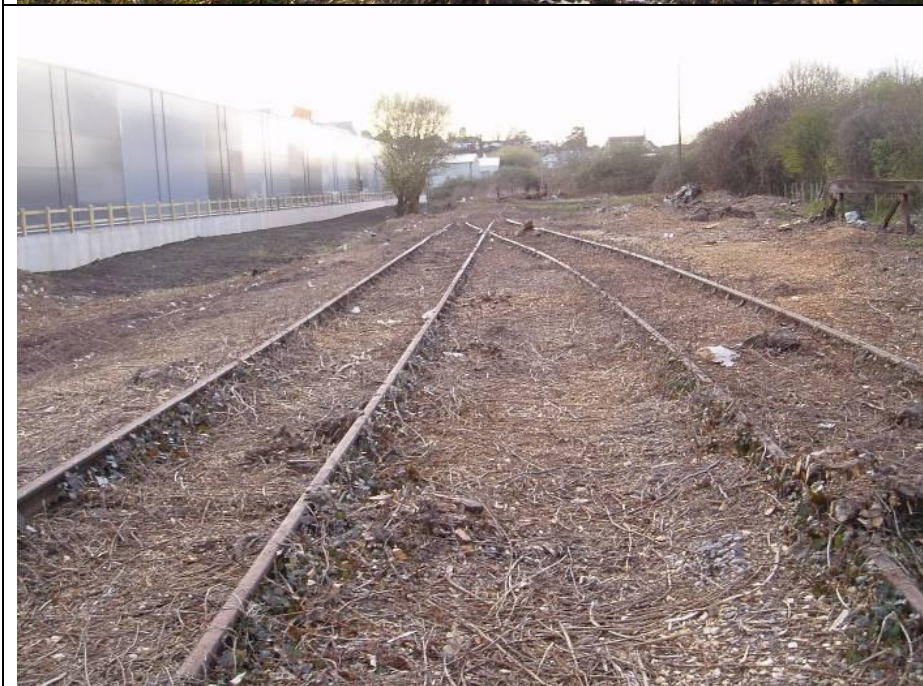
Photo 3260145

The twin tracks converge at points near the end of the line. These points and the previous points provided a "run around" track for a locomotive.

Note the lone buffer at the right-hand edge of the photo; the sole remaining hint that many sidings were once around here.
